ANNUAL REPORT FOR 2000

Spring Branch Mitigation Site

New Hanover County

Project No. 8.2250109

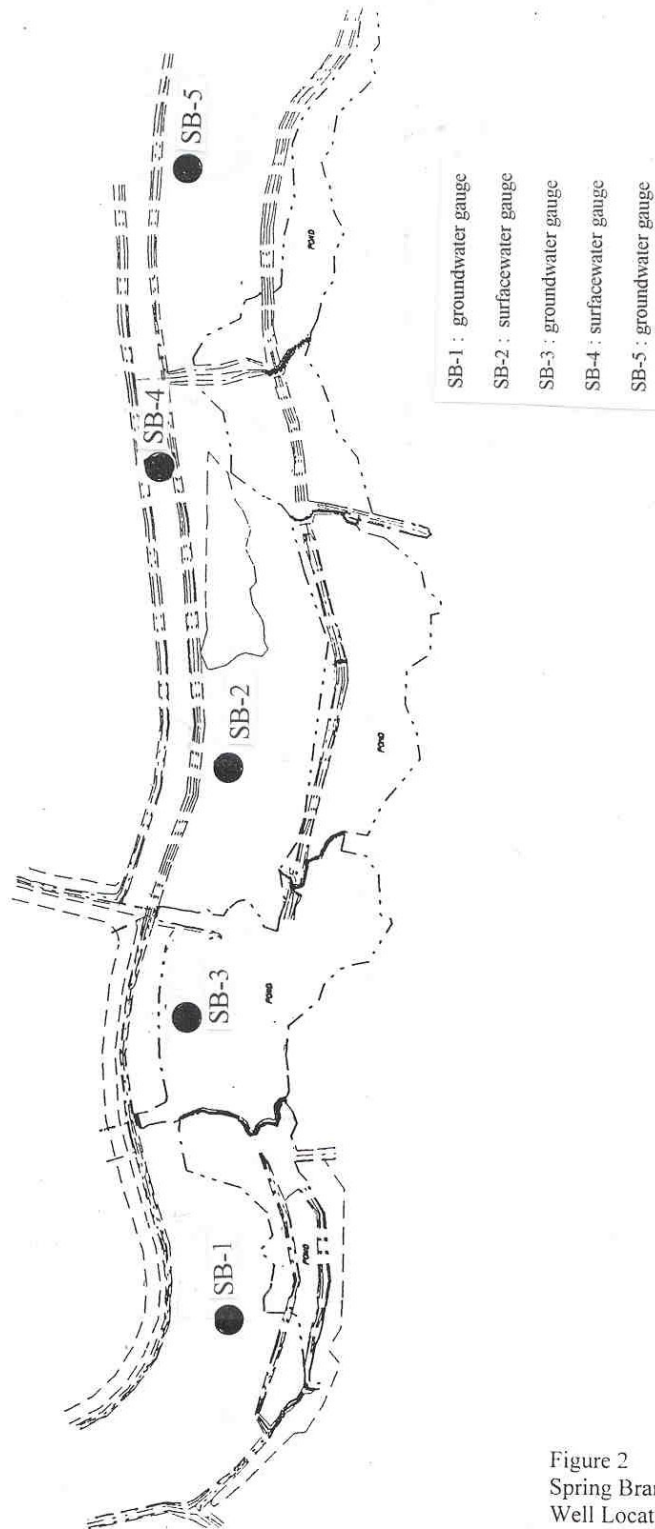
Figure 2
Spring Branch Mitigation Site
Well Location Map

Three monitoring wells, two surface gauges, and one rain gauge were installed in March of 1998 (Figure 2). Because of the amount of surface water on the site, each groundwater well was installed to record water levels both above and below ground level. Daily readings are taken throughout the growing season.

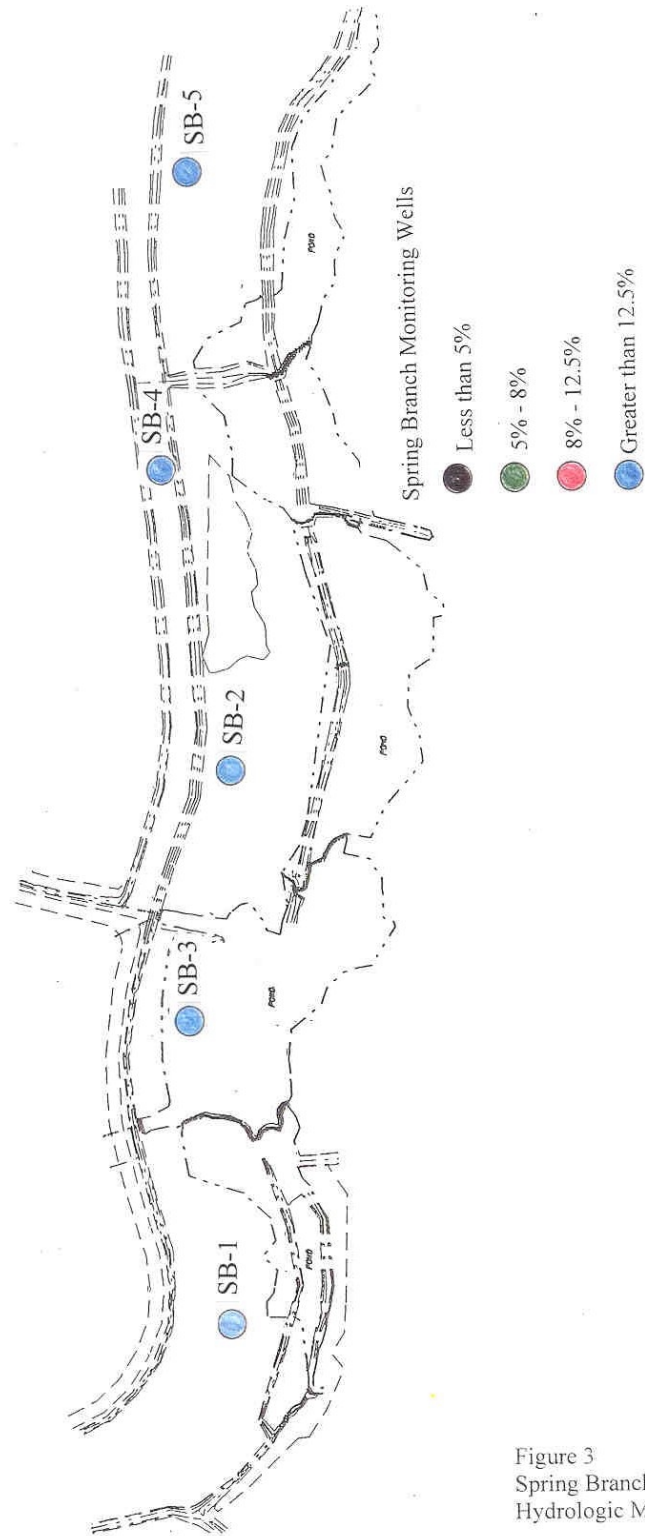
Figure 3
Spring Branch Mitigation Site
Hydrologic Monitoring Map

The three wells on the site recorded the water table within 12 inches of the surface for more than 12.5% of the growing season. The surface water gauges indicated a consistent presence of surface water throughout the growing season. Figure 3 is a graphic representation of the 2000 monitoring results.

The Spring Branch Mitigation site met the hydrologic success criteria during 2000. The hydrologic monitoring results were consistent with results from 1998 and 1999, with the soil saturation at the surface or inundation of the site throughout the majority of the growing season.

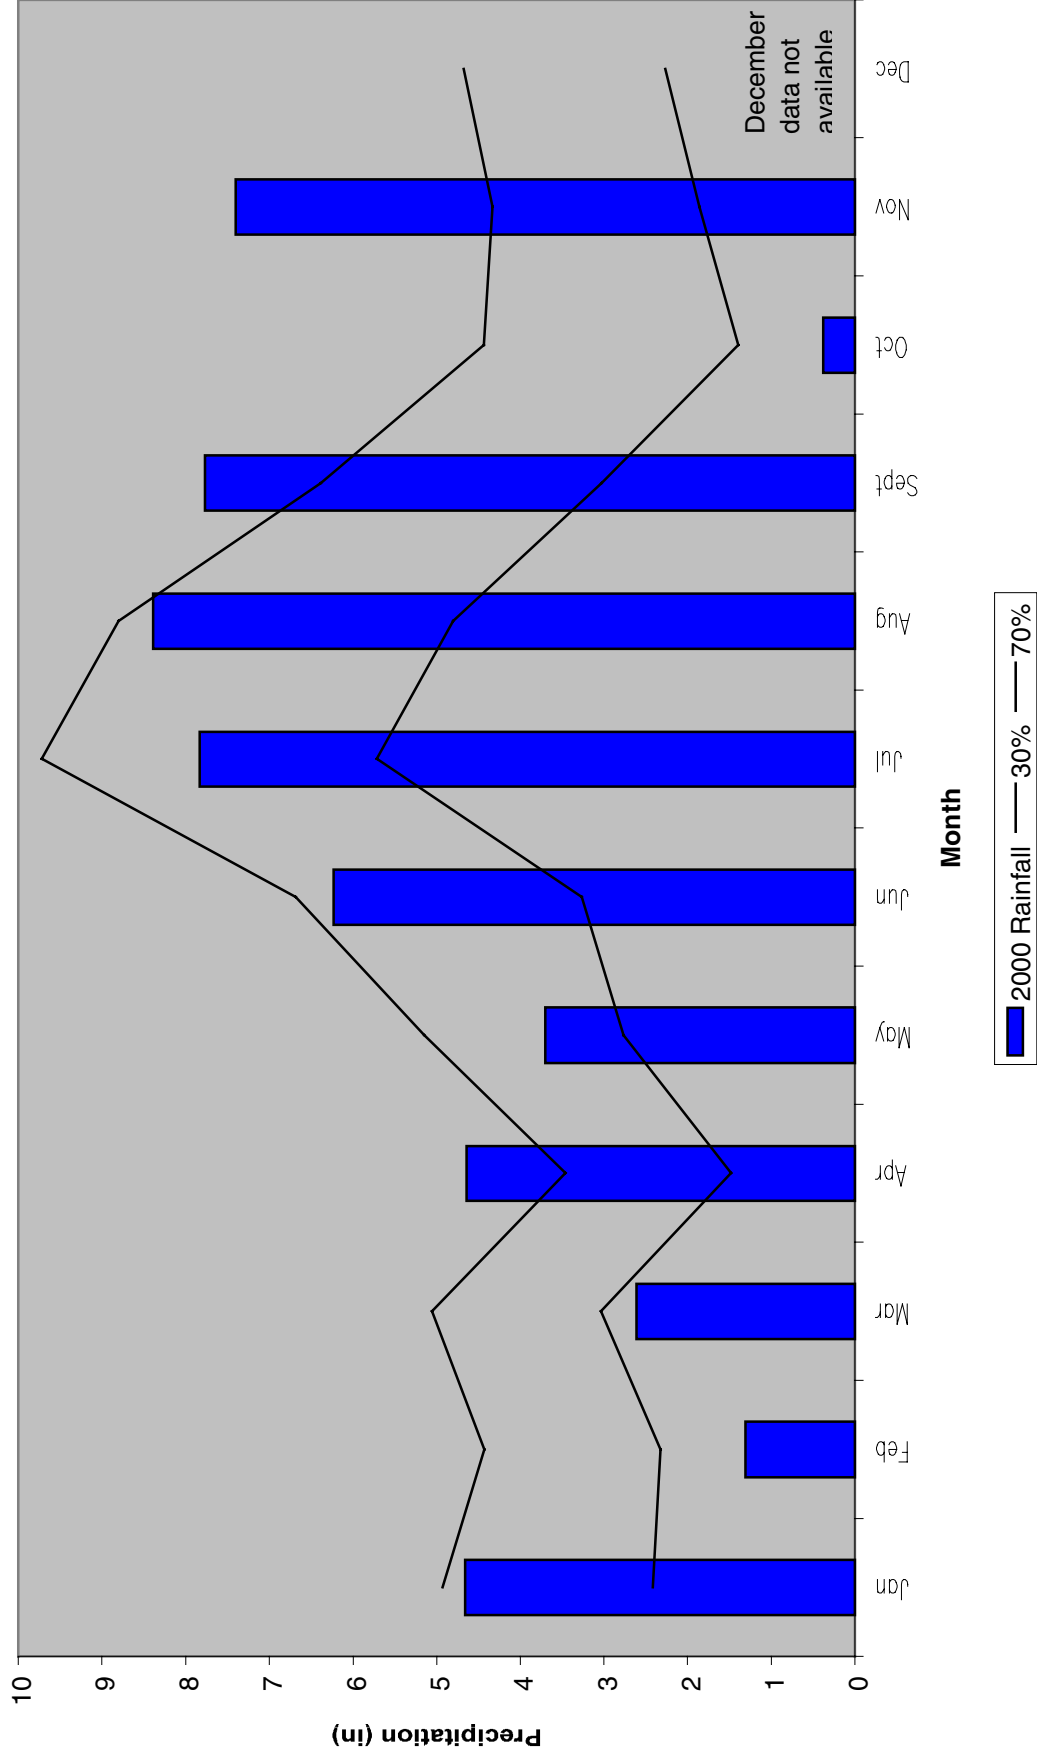
**Figure 4. Spring Branch 30 - 70 Percentile Graph
Wilmington, NC**

Figure 4 represents an examination of the local climate in comparison with historical data to determine if 2000 rainfall falls within the average rainfall range of the area. The historical data was provided by the National Climatic Data Center; the recent rainfall data was provided by the State Climate Office at NC State University.

February, March and October were the only months with below average rainfall for the Wilmington area. Monthly rainfall totals for the majority of the growing season were within or above the average monthly range.

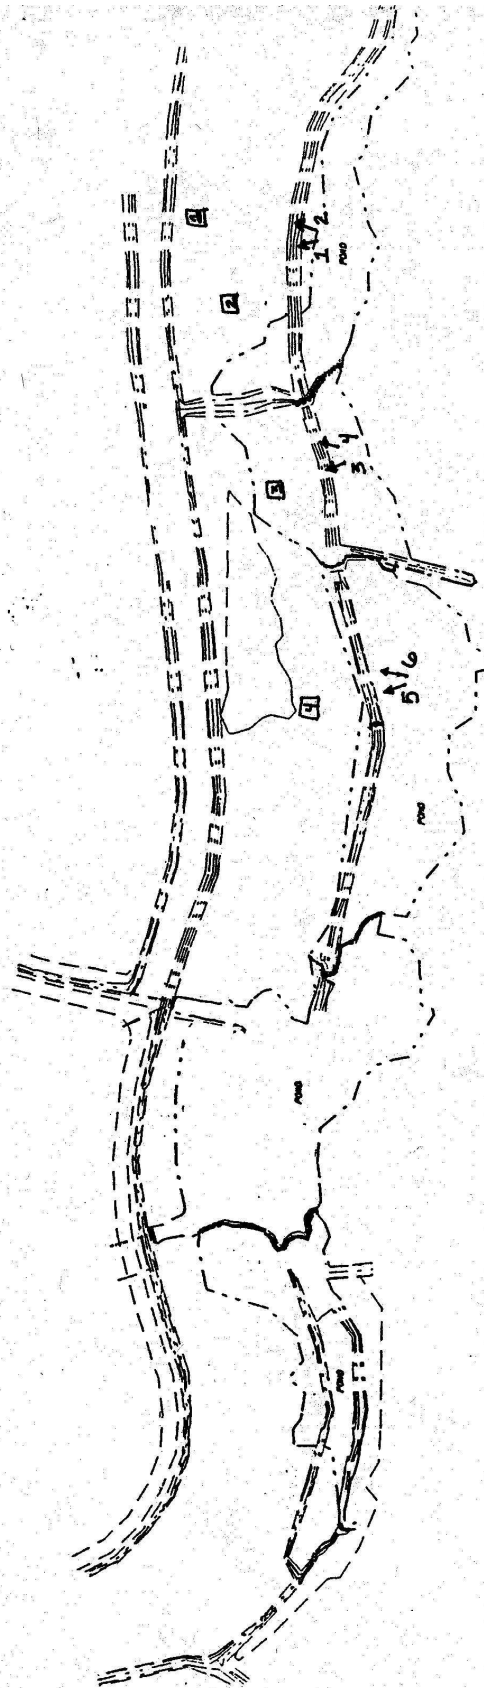
Figure 5.
Spring Branch Mitigation Site
Approximate Plot and Photo Locations

To determine tree density, 50' x 50' plots are installed immediately following Planting (Figure 5). The actual number of planted trees which occur within the plot are counted. This number is equated to the number within each plot, which represents 680 trees per acre (average). The survival monitoring number is compared to the planted number to obtain survival percentage. This percentage is applied to the 680 trees per acre to obtain an estimated tree per acre for the site. (Density = monitoring count / planted trees x 680)

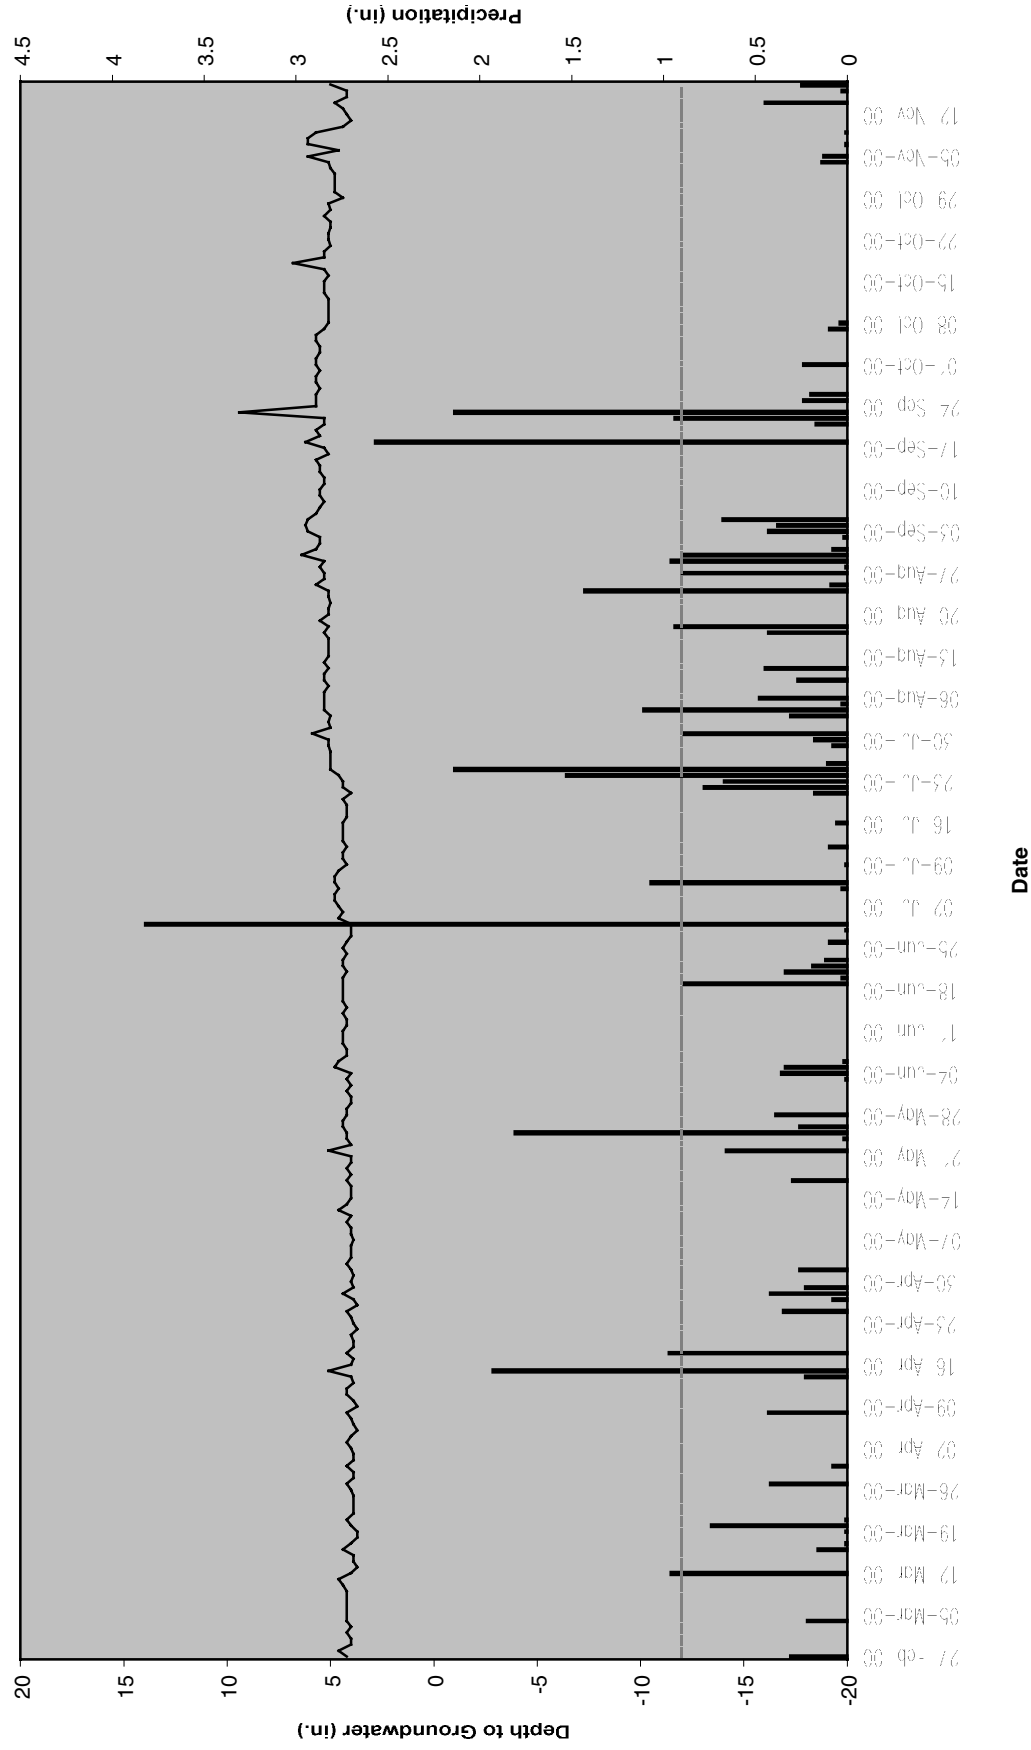
Spring Branch SB-1

■ Rainfall- NC Climatic Data — 02140F5 SB-1 - - - - - Required Depth

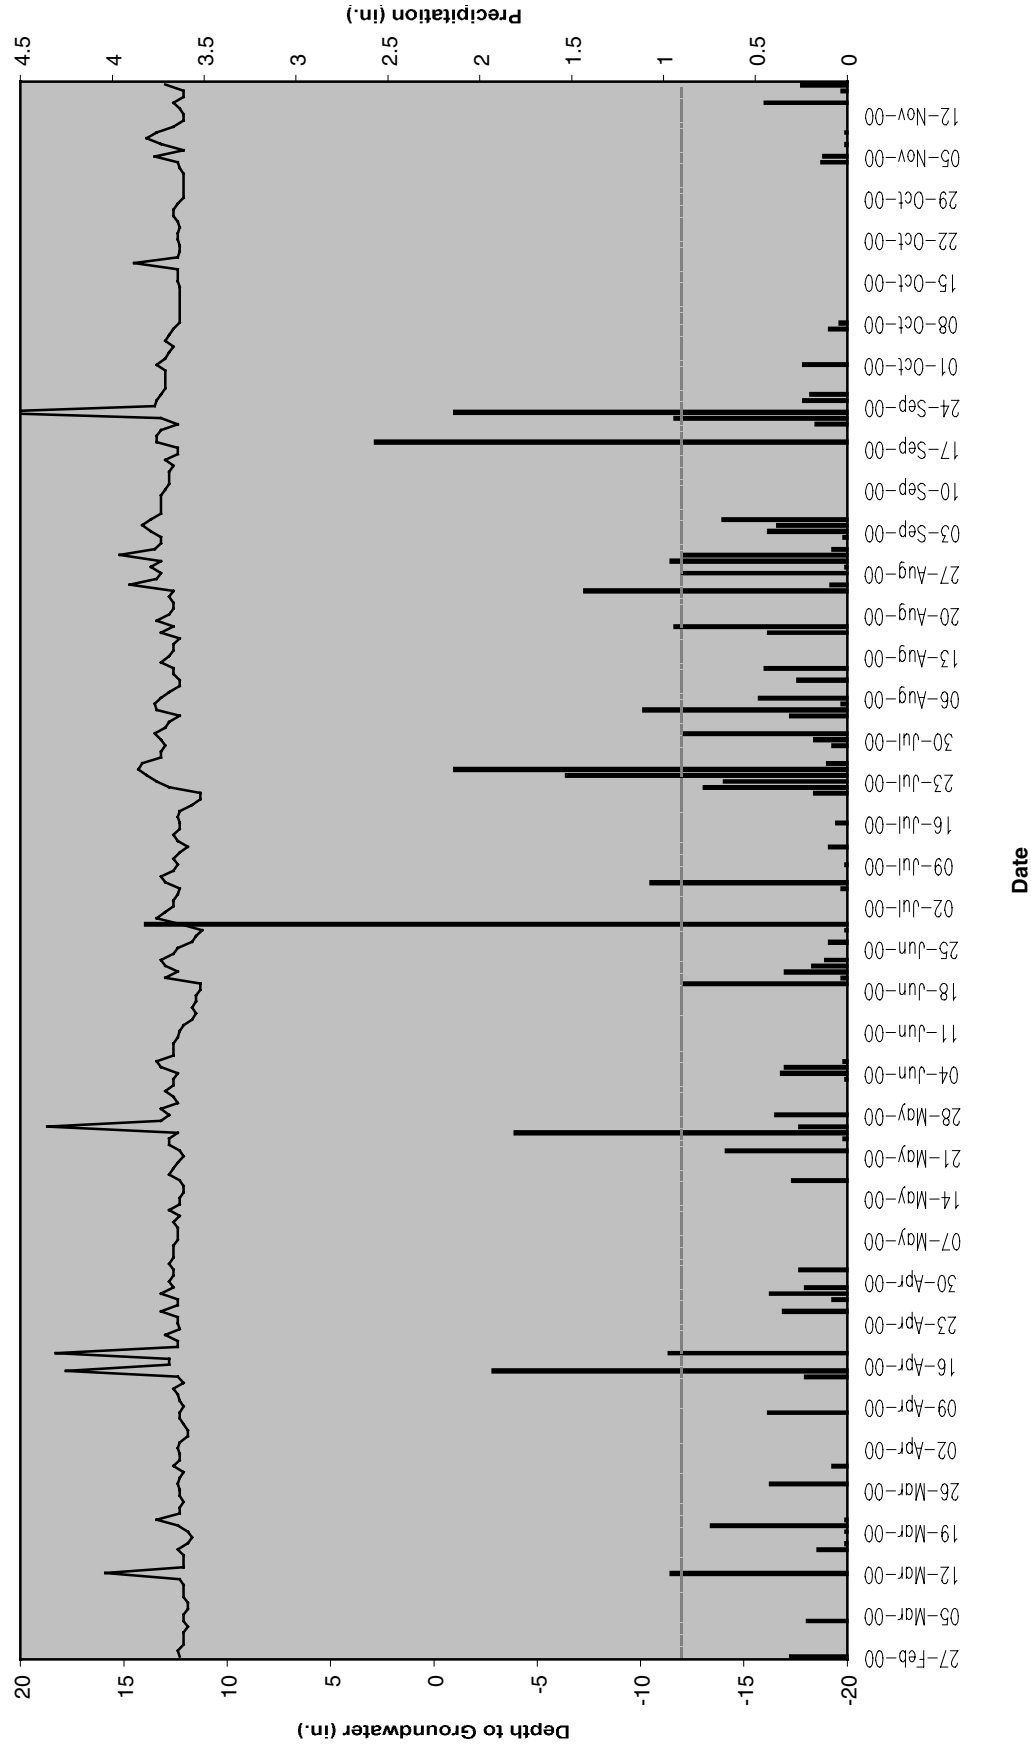
Spring Branch SB-3

■ Rainfall- NC Climatic Data — 0213D90 SB-3 - - - - Required Depth
